OZIAS HUMPHRY (1742-1810), *PORTRAIT OF JANE AUSTEN*

Oil on canvas, 142,2 x 92,7 cm

CONDITION AND CONSERVATION 9/2011

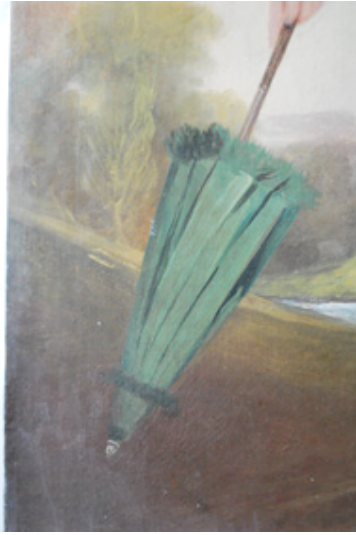
Fig.1: Detail of the umbrella before cleaning:
Lower left angle
Photo : © Eva Schwan, 2010

Details showing the greyish veil altering the paint layer due to important accumulations of wax and resin. Important accumulations of wax and resin are particularly visible in the interstices of the cracks.

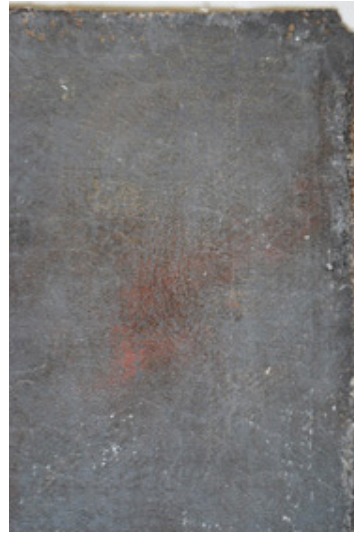
Fig.2: Detail before cleaning:
Upper right angle in the sky
Photo : © Eva Schwan, 2010

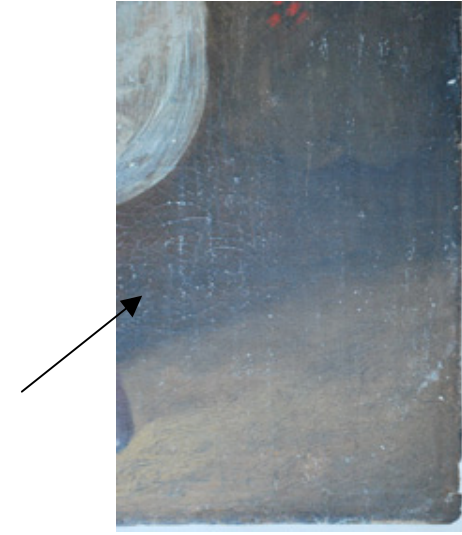
Fig.3: Detail before cleaning:
Lower right angle
Photo : © Eva Schwan, 2010

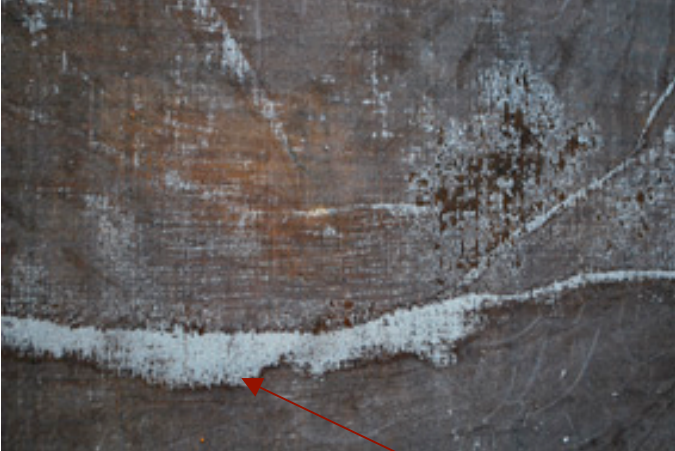
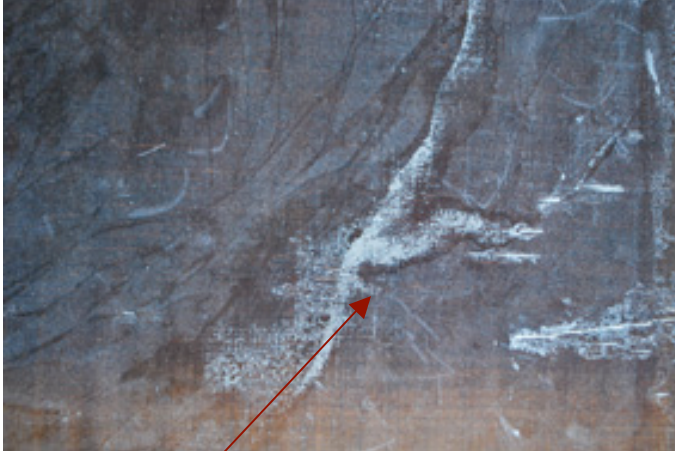
<p>Fig.4 and 5: Details showing the irregularly applied Beva@371 wax and resin mixture applied on the back of the original canvas. Photos: © Eva Schwan, 2010</p>		<p>Fig.6: General view: back of the canvas Photo: © Eva Schwan, 2010</p>

One of the most protracting interventions had been the tedious extraction of the considerable amount of wax and resin heavily impregnating both sides of the canvas. Retouching was removed along with the varnish, which allowed us to remove excess fillers over areas of intact paint and other tenacious residues trapped in the cavities of the painting.

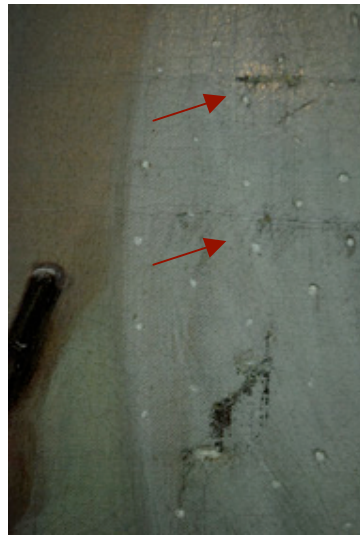
Both techniques (glue-lining and lining with synthetic wax/resin mixtures) implying heat and pressure, they were disastrous as to the original condition and aspect of the paint layers: impasto was irreversibly squashed, original brushstrokes flattened, surface effects such as the white dots crushed, in some areas, the canvas structure is reinforced into the surface texture of the paint (weave re-enforcement). Cracks in paint and ground caused by strain from movement of the support are visible all over the surface of the painting. After cleaning, previously retouched stretcher marks along with cracks and losses were clearly visible.

Fig.7: Details of the painting during cleaning:
Cracks and losses along stretcher marks
Photo : © Eva Schwan, 2010

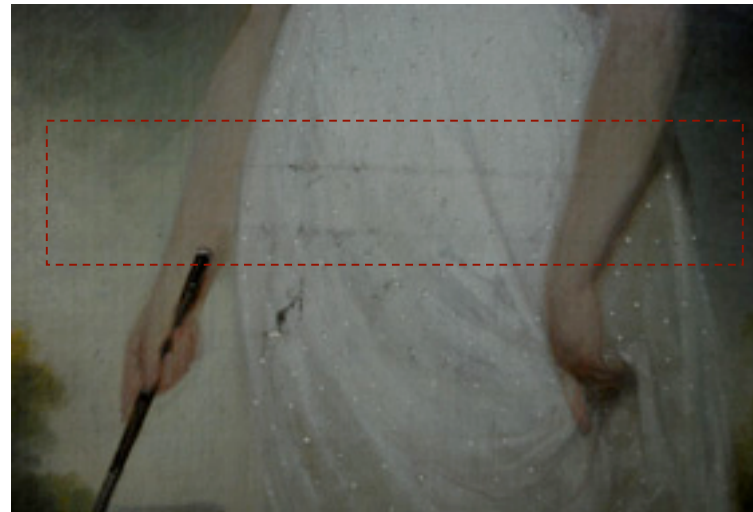
Fig.8: Details of the painting during cleaning:
Cracks and losses along stretcher marks
Photo : © Eva Schwan, 2010

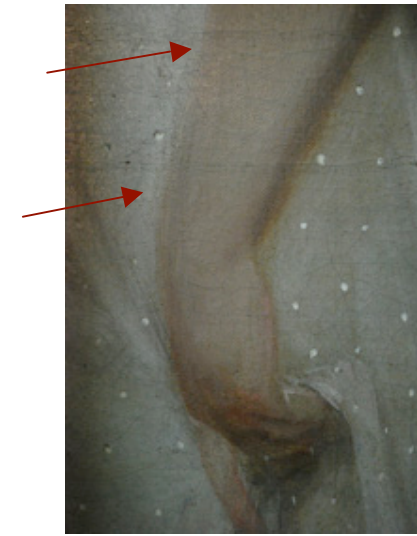
Fig.9: Details of the painting during cleaning:
Cracks and losses along stretcher marks
Photo : © Eva Schwan, 2010

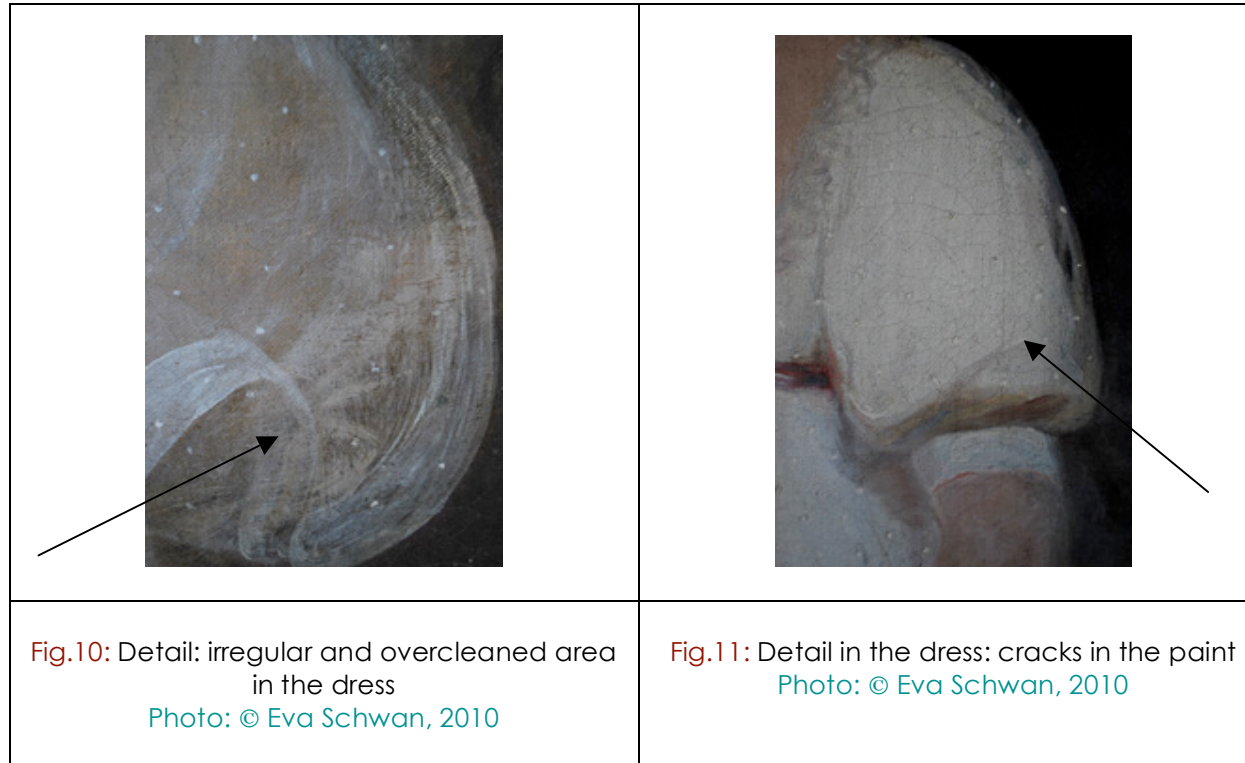
Another kind of cracking caused by stresses within the paint itself can be seen in areas of thick paint layer such as the cracks in the white dress.

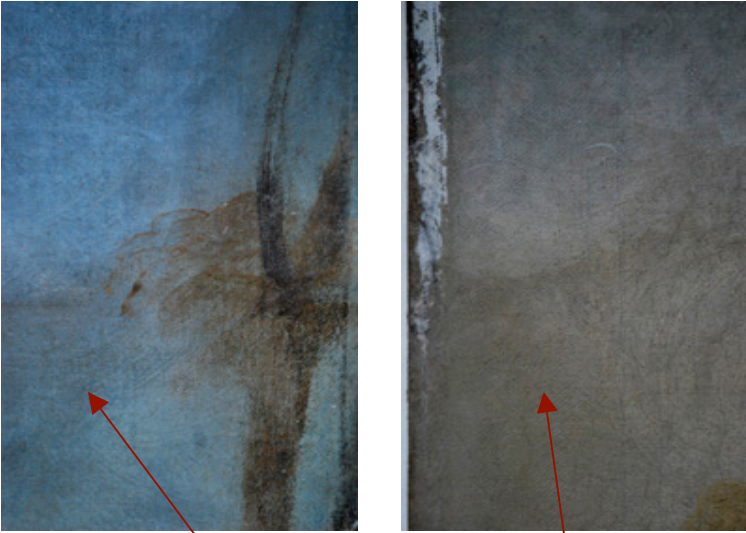
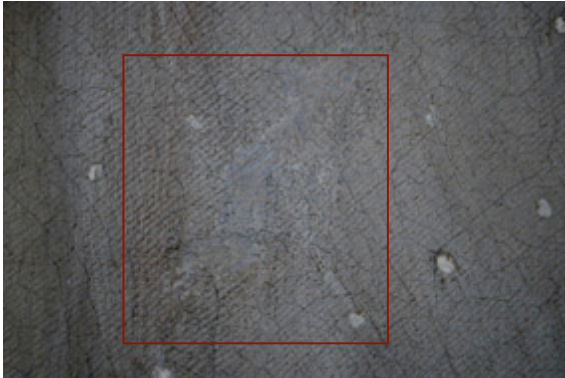
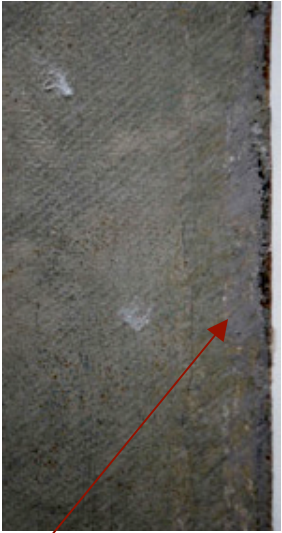
White coloured filling material was applied in some of the losses. The filling was used to even out the losses in the painting, and was applied without much consideration, since it often overlaps the surviving original areas. Previous interventions on the paint layer consisted of tonal repair of large missing areas, and retouching of smaller losses. Unfortunately, retouching was not restricted to areas of loss only, rather in contrary, it seems extensive retouching was done with the intention of having compensated surface abrasions and areas of loss in the original paint. The surface was heavily coated with a synthetic resin varnish layer, applied over an irregular cleaned surface with yellow and brown accumulations of varnish lodged in the paint depressions. It was also found that dust and surface grime was trapped in the cavities of the original paint layer, accentuating the irregular surface aspect.

<p>Fig.12 and 13: Detail during cleaning: Note the patchy surface appearance due to grime, dirt and retouching Photo: © Eva Schwan, 2010</p>	<p>Fig.14: Detail in the dress: previous retouching Photo: © Eva Schwan, 2010</p>	<p>Fig.15: Detail of the right border: Previous retouching Photo: © Eva Schwan, 2010</p>

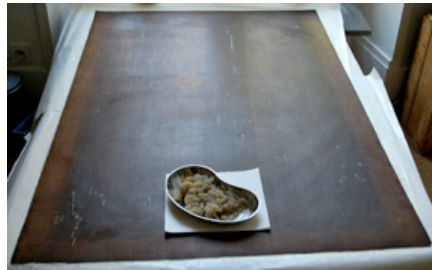
Fig.16: After extraction of the wax/resin mixture
Photo : © Eva Schwan, 2010

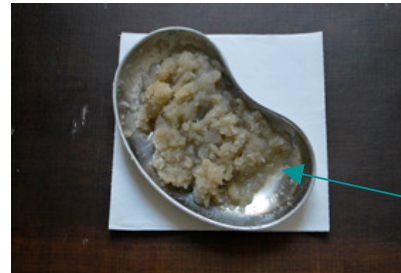
Fig.17: Extraction of the wax/resin mixture
Photo : © Eva Schwan, 2010

Only a small sample of the important amount of the synthetic wax and resin mixture, Béva®, that has been extracted.

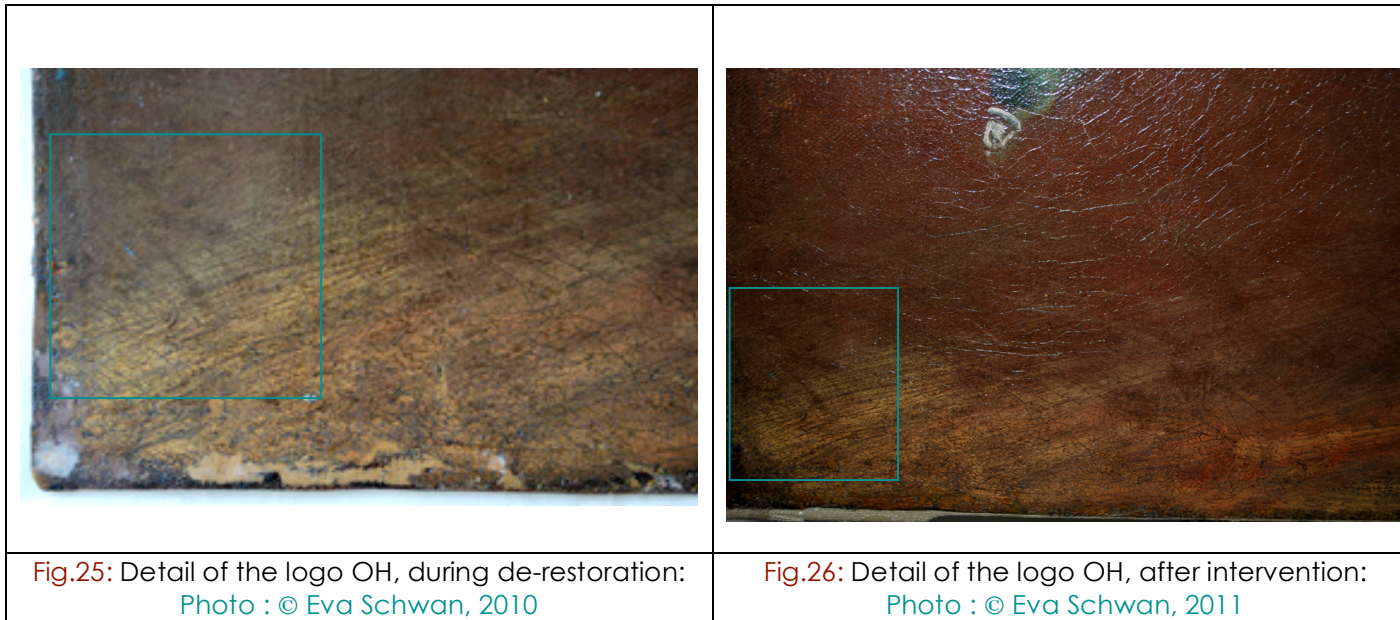
Another detail had been suppressed by earlier restorations: although severely damaged by cleaning in the past and concealed with excessive retouching, it would appear to be one of the most important details as to the signature of the artist, the initials OH in the left hand corner of the painting. Although severely damaged by surface abrasion, even the uncovered fragments of the initials play undoubtedly an essential role in the attribution of the painting.

Ozias Humphry's identifying monogram of his initial letters, O and H, the H being encircled with the O, is located in the lower left angle of the painting, at 2cm from the left edge and 2.5cm from the lower edge.
The logo OH has a diameter of 3cm.

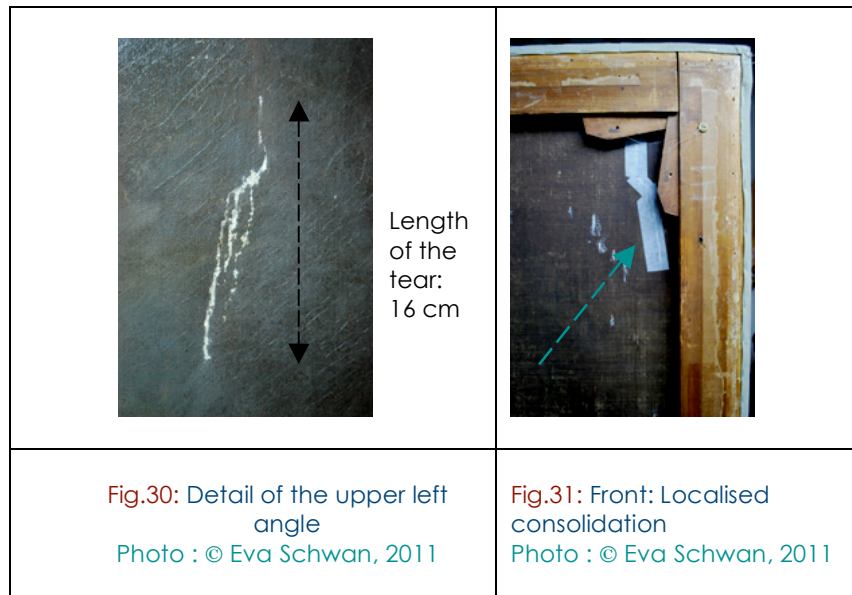
While being perfectly reversible, the strips are strong and flexible enough to hold the torn edges in place. Although examination in raking light clearly shows a vaulted appearance in this particular area, it does not disturb the lecture of the composition. Rather in contrary, accepting this deformation – while being aware of the history of the painting – allows us to appreciate a maximum of the original substance and aspect of the painting – front and back -. However, a loose cushion has been placed between this particularly frail area and the stretcher in order to brace the canvas, to protect it from impacts and to absorb any vibrations.

Adopting a less interventionist approach, lining (or rather re-lining) seems to be unnecessary. Indeed, after careful examination, the original canvas appears to ensure sufficient resilience and carrying capacity, without lining. Therefore, for the time being, we decided to preserve the original state of the canvas as much as possible, which means no lining. The tears could be repaired *in situ*: occasional deformations of the structure around the immediate area of some of the tears were levelled with weights and moisture. With the yarns aligned, the tears were reinforced with localised application of an adhesive strong enough to keep the damaged structure in plane. The 16 cm long tear in the upper quarter required more support. The damaged area has been temporarily strengthened with the application of medical strips, *micropore*.
